# Manhole Inspection Summary

Manhole # S27W\_\_001MH

**Location** Address: **S Monroe st**

Cross Street: **Russell St**

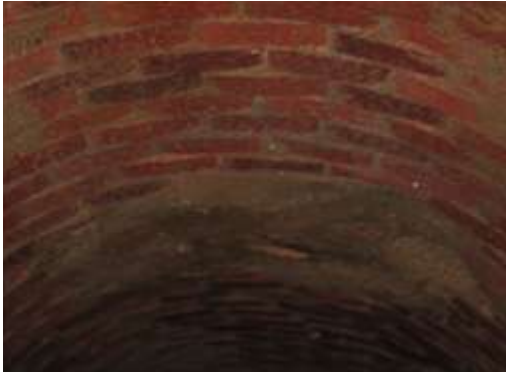
patch work in m/h

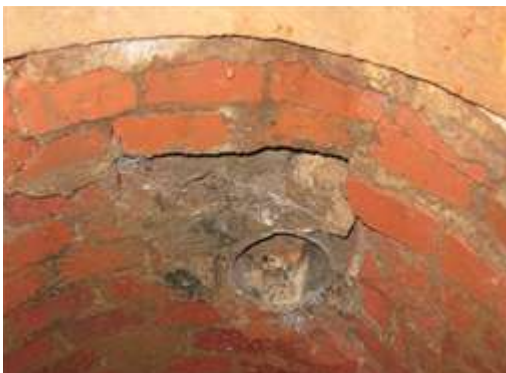
Defect 4

Condition: ☐ Sound ☒ Cracked ☐ Root Intrusion ☒ Loose Brick ☒ Deteriorated

Missing bricks, deteriorated corbel surrounding pipe

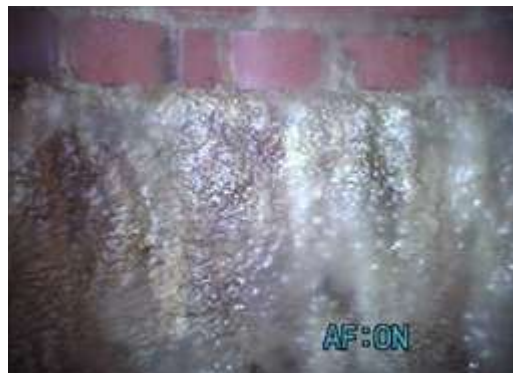
Defect 5

Infiltration: ☐ None ☐ Joint ☐ Cracks ☒ Mortar ☐ Roots ☒ Wall

Barrel infiltration

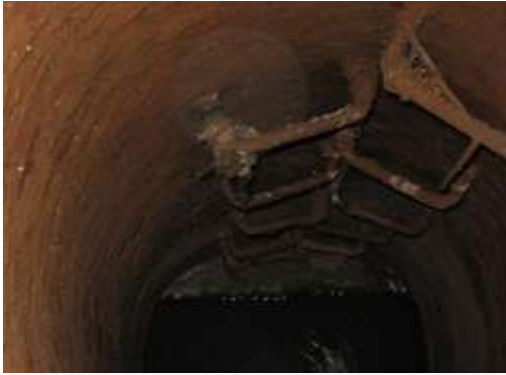
Defect 3

Condition: ☐ Sound ☐ Cracked ☐ Root Intrusion ☒ Deteriorated ☐ Leaks ☐ Debris

Count: **11** Missing: **0** ☒ Corroded

☒ Evidence Of Surcharge Depth: **12** (ft.) ☐ Active Surcharge Present

corroded steps and surcharge evidence,  
deteriorating bench

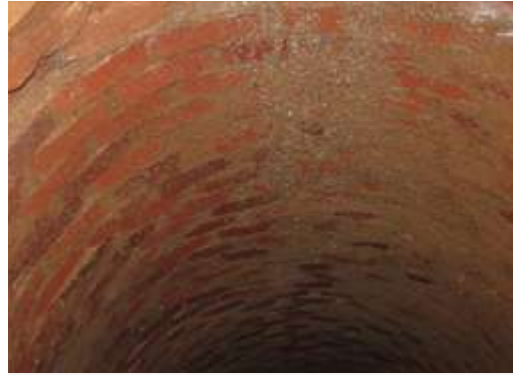
Defect 2

Infiltration: ☐ None ☐ Joint ☒ Cracks ☒ Mortar ☐ Roots ☒ Wall

infiltration in corbel

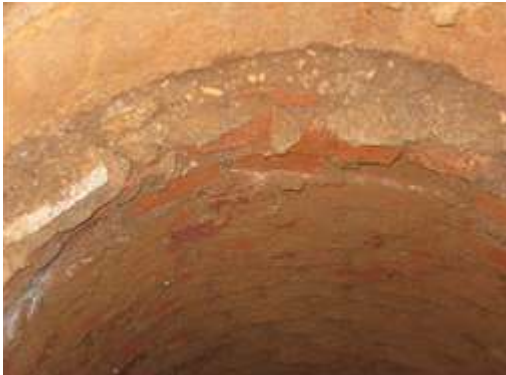
Defect 1

Offset: **0.5** (in.)

Condition: ☐ Sound ☐ Cracked ☐ Root Intrusion ☒ Loose Brick ☒ Deteriorated

Infiltration: ☐ None ☐ Joint ☐ Cracks ☒ Mortar ☐ Roots ☒ Wall

offset about .5 inch, loose bricks and  
deterioration in chimney

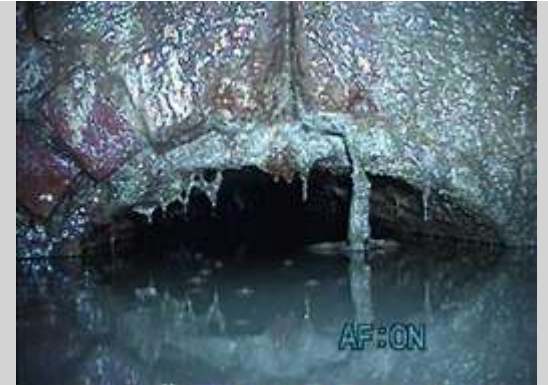
12 O'Clock Outflow

Pipe Height: **19.2** (in.) Rod and Bar (Angled)  
Pipe Material: **Clay** ☐ Pipe Lined  
Invert Depth: **19.92** (ft.) Flow Characteristics: **Slow**  
Deposits: ☐ None ☐ Mud ☒ **Sludge** ☐ Debris ☐ Grease  
Silt Depth: **10** (in.) Deposits Extent: **Heavy**  
Infiltration: **Evidence** Pipe Seal Cond: **Unknown**

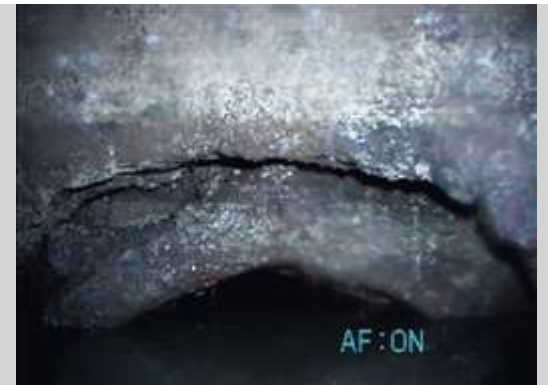
6 O'Clock Inflow

Pipe Height: **18** (in.) Rod and Bar (Angled)  
Pipe Material: **Clay** ☐ Pipe Lined  
Invert Depth: **20.05** (ft.) Flow Characteristics: **Slow**  
Deposits: ☐ None ☐ Mud ☒ **Sludge** ☐ Debris ☐ Grease  
Silt Depth: **10** (in.) Deposits Extent: **Heavy**  
Infiltration: **Evidence** Pipe Seal Cond: **Unknown**

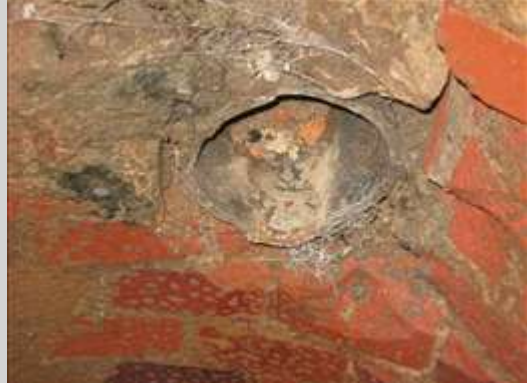
7 O'Clock Inflow

pipe coming into MH and missing brick and mortar surrounding pipe
